# **Impact-Echo Scanning for Grout Void Detection in Post-tensioned Bridge Ducts - Findings from a Research Project and a Case History**

(presented at ASCE Structures Congress, Long Beach, California, May 2007)

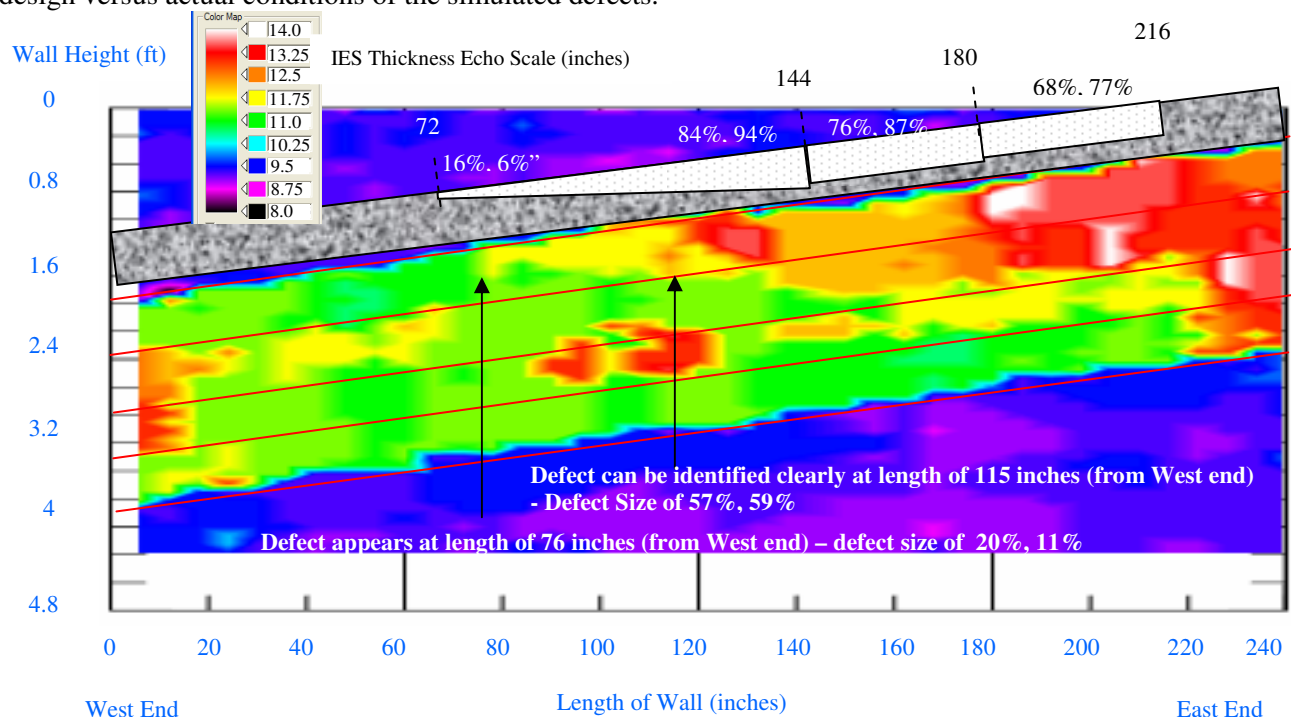
**South Wall – Top Duct:** The IE Scanner results from the South Wall with the actual defect design of the top duct placed above the IE results of the top duct are shown in Figure 5. The results are interpreted to indicate that the grout defect started to appear at a length of 1.93 m (76 in) and becomes clearly evident at length of 2.92 m (115 in) from the west end of the duct. The location that the defect starts to appear corresponds to void with 11% depth lost or 20% circumferential perimeter lost. The location that the grout defect become more evident corresponds to void with 59% depth lost or 57% circumferential contact diameter lost. The dominant frequency of the fully grouted duct is approximately 6.4 kHz, resulting in an apparent Impact-Echo thickness of 28.37 mm (11.17 in.). The dominant frequency shifted downward to approximately 5.37 kHz for an empty duct, which corresponds to an apparent Impact-Echo thickness of 340 mm (13.4 in). This is a relatively large thickness shift of over 30% compared to the nominal thickness of the wall. The interpretation of the Impact-Echo Scanner results, however, shows a downshift in frequencies from lengths of 5.49 to 6.1 m (216 to 240 in), indicating voids at duct locations where no discontinuities were intentionally placed. It is likely that grout did not flow into the higher east duct end due to the big voids in front of it. Radiographic tests will be performed in the future to verify the design versus actual conditions of the simulated defects.

FIGURE 5 – IE RESULTS FROM THE SOUTH WALL WITH ACTUAL DESIGN DEFECTS OF TOP DUCT

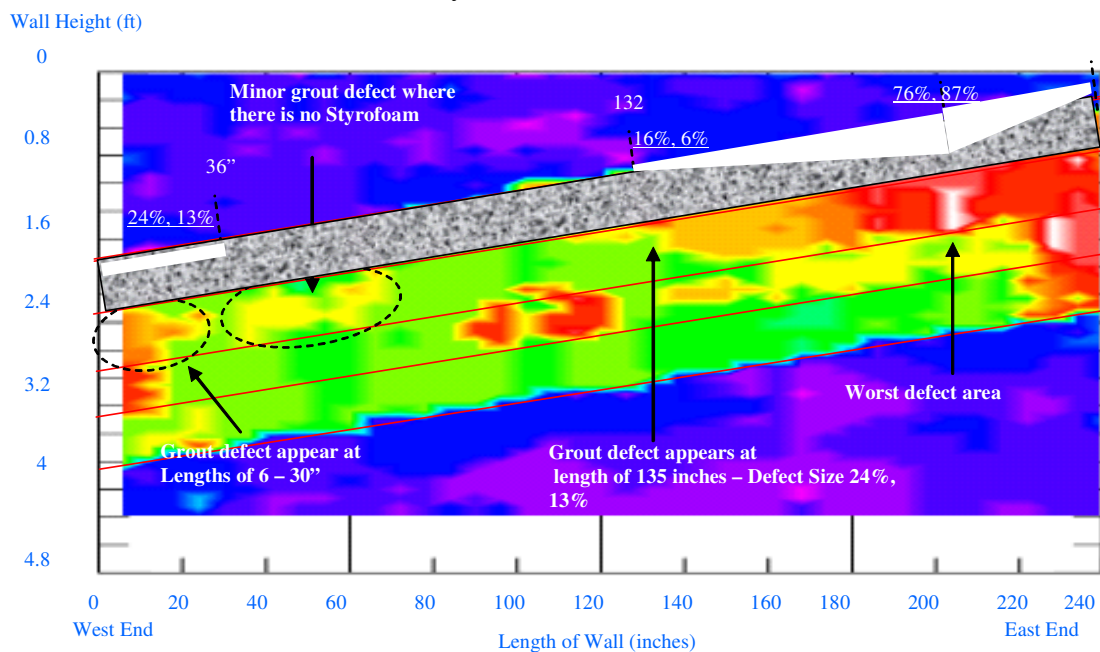
South Wall – Second Duct from Top: Review of Figure 6 shows that there are three grout defect zones. The first grout defect zone correlates with the end defect (13% depth lost or 24% circumferential lost). The second defect zone shows minor grout problem from lengths of 0.91 – 1.67 m (36 – 66 in) from the west end of the duct. However, there is no actual defect placed in this area. Radiography is required to confirm the realization of defect designs. The third defect zone appears at a length of 3.35 m (132 in) which corresponds to defect of 9% in depth lost or 18.5% in circumferential lost. The most apparent grout defect appears at a length of 5.18 m (204 in) corresponding to the location of the largest Styrofoam in the duct (87% depth lost or 76% circumferential perimeter lost). Similar to the results from the top duct, the interpretation of the Impact-Echo Scanner results, however, shows a downshift in frequencies from lengths of 5.18 to 6.1 m (204 to 240 in), indicating major voids at duct locations where actual defect shape tapers down toward the east end. It is likely that grout did not flow into the east end due to the large voids in front of it.

FIGURE 6 – IE RESULTS FROM THE SOUTH WALL WITH ACTUAL DESIGN DEFECTS OF SECOND DUCT

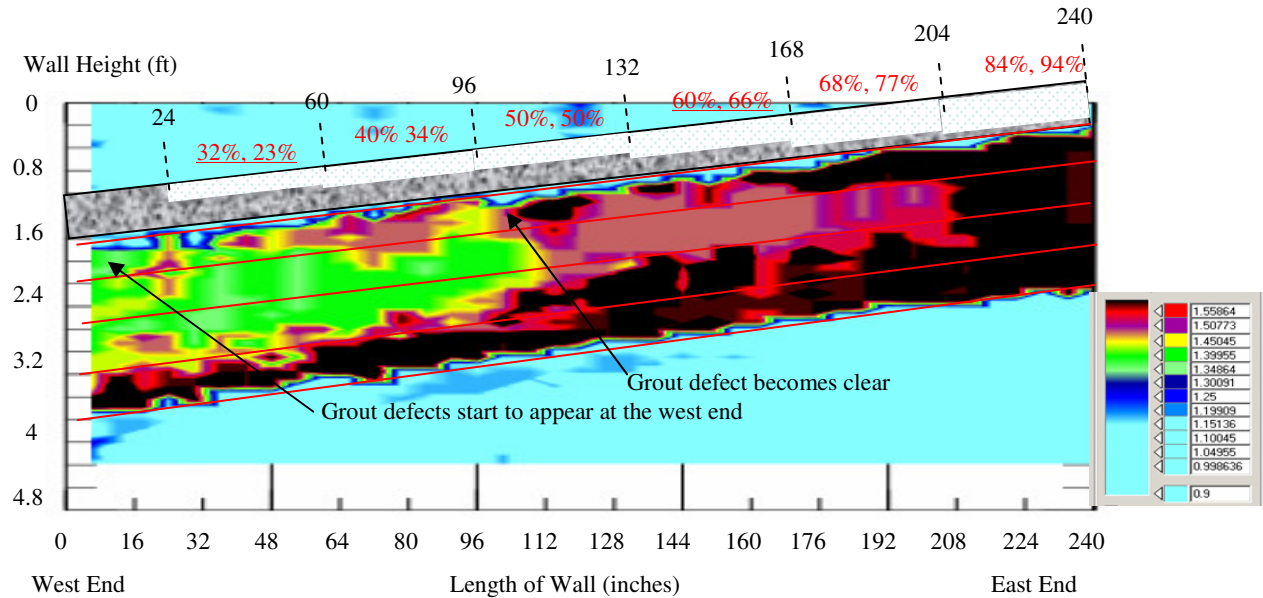
FIGURE 8 - IE RESULTS FROM THE NORTH WALL WITH ACTUAL DESIGN DEFECTS OF TOP DUCT AND THE NORMALIZED THICKNESS SCALE

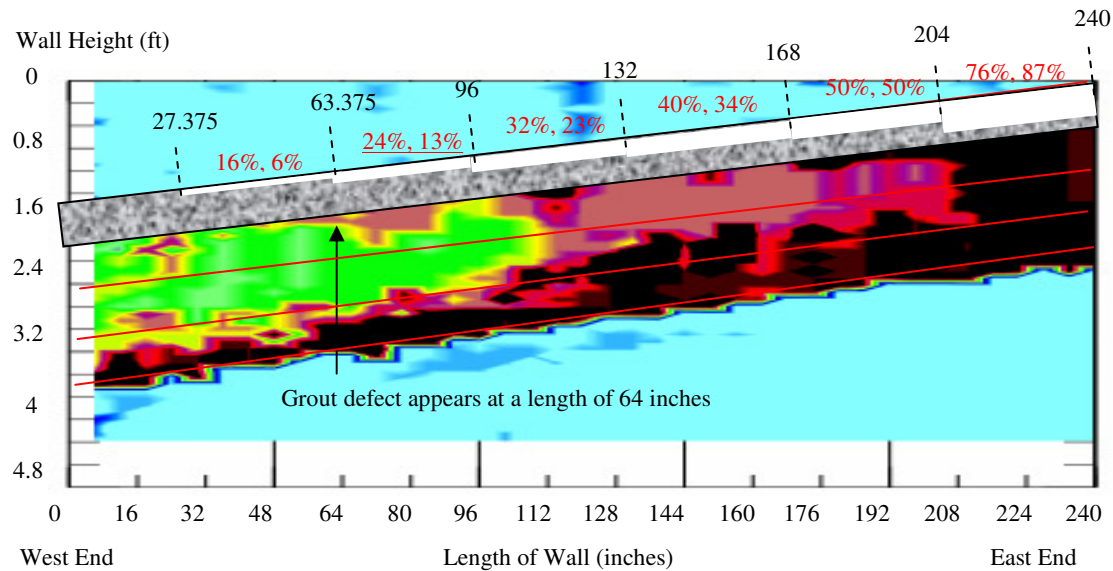
North Wall – Second Duct from Top: Several pieces of stepped Styrofoam were inserted inside this duct ranging from depth lost of 6% to 87% or circumferential lost of 16% to 76%. Review of Figure 9 shows that the grout defect started to appear at a length of 1.62 m (64 in) from the west end of the girder. This length corresponds with location with voids of 13% lost in depth or 24% circumferential lost.

FIGURE 9 – IE RESULTS FROM THE NORTH WALL WITH THE ACTUAL DESIGN DEFECTS OF THE SECOND DUCT

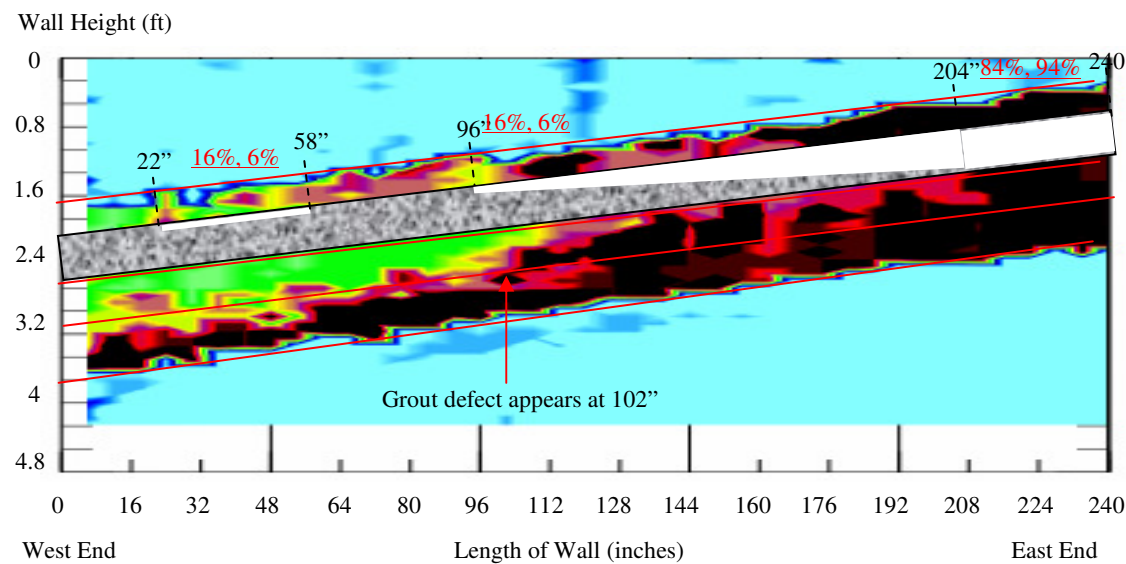
North Wall - Third Duct from Top: Review of Figure 10 shows that the grout defect started to appear at a length of 2.59 m (102") from the west end of the girder. This location corresponds to void of 11% depth lost or 19% circumferential lost. In this case, the grout defect appear to be apparent (full depth void) right at a length of 3.35 m (132 in) from the west end. This location corresponds to void of 35% depth lost or 39% circumferential lost.

FIGURE 10 – IE RESULTS FROM THE NORTH WALL WITH THE ACTUAL DESIGN DEFECTS OF THE THIRD DUCT

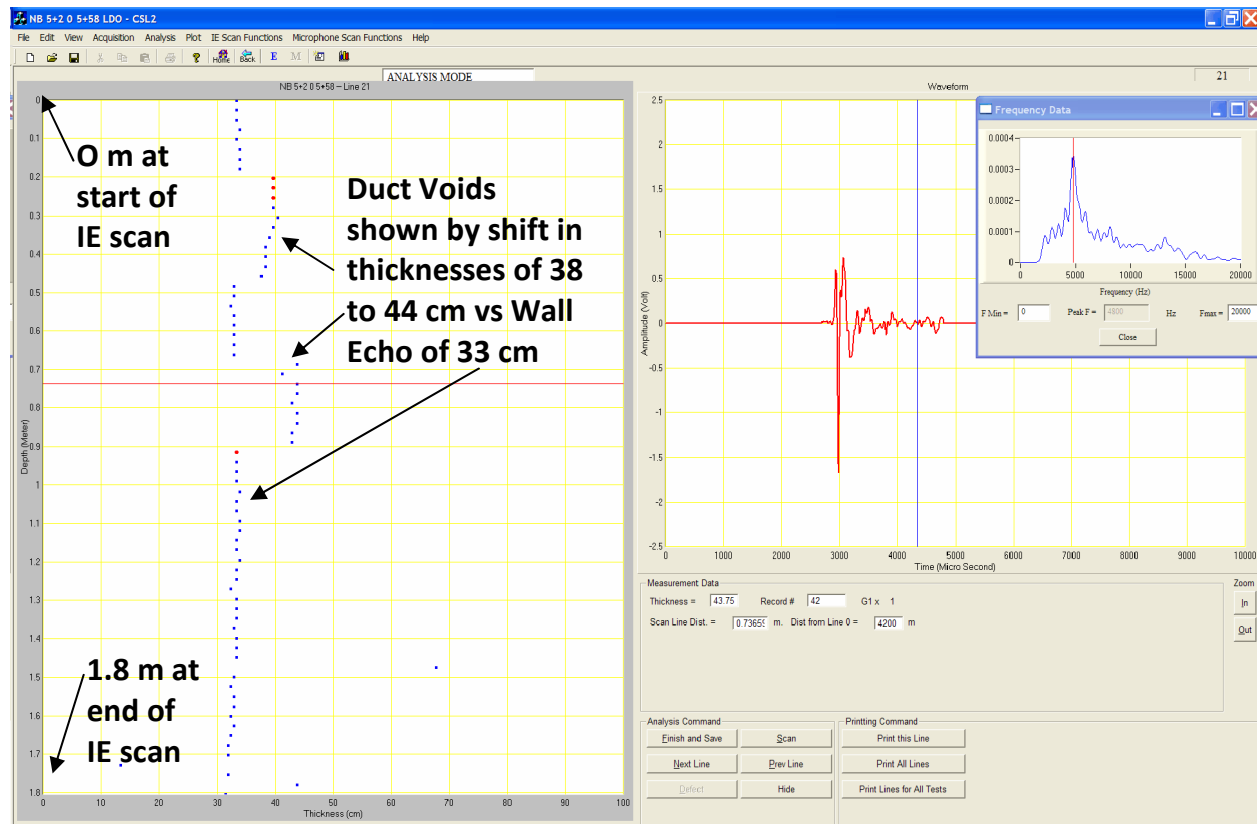
the bottom inside chamfer and ran to the top inside chamfer of the tested web walls for about 72 tests over 1.8 m of wall. A 2-D scan vertically up the wall from 0 to 2 m is shown in Figure 12. The 2-D results shows a single time domain result and the corresponding linear frequency displacement spectrum showing the resonant thickness echo peak along with the thickness vs. distance plot that is the 2-D IES result. Potentially voided ducts are indicated by the greater thicknesses in 2 locations (lower resonant frequency echo peaks due to voiding) in Figure 12. The results from the tests are presented in a thickness tomogram fashion for each web wall for each tested span with thicker areas indicative of potential void in the PT Ducts. An example test result from one of the spans is presented in Figure 13. Review of Figure 13 shows discontinuities or voids located at 20 m from Pier 2 and from the bottom of the wall (location where the scan started) to a height of 0.6 m. The IE records indicated cracks/voids at depths of 12 – 15 cm from the test surface. In addition, the plot in Figure 13 also indicated a thicker area (presented in black color) representing voids inside the duct(s) located at 42 m from Pier 2 and from heights of 0.9 – 1.15 m. The color map in Figure 13 shows normalized thicknesses (the IE thickness divided by the nominal thickness at the tested line) by color from 0.1 to 1.3.

FIGURE 12 – VERTICAL IMPACT ECHO SCAN WITH 2 DUCT VOIDS OF 33 CM THICK WALL SECTION WITH 100 MM DUCTS

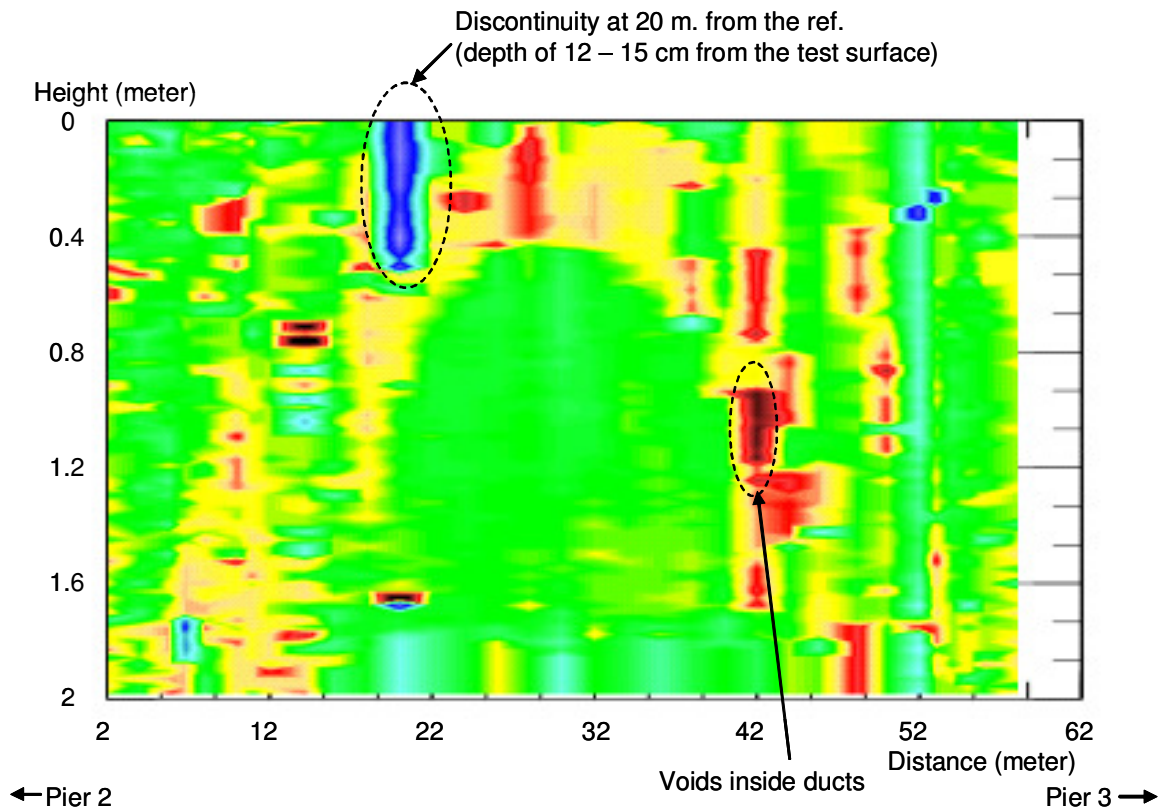
FIGURE 13 – 3D NORMALIZED THICKNESS TOMOGRAM OF SPAN 2 OF NORTH BOX (GENERAL CONDITION)
