APPLICATION OF A COMBINED NONDESTRUCTIVE EVALUATION APPROACH TO DETECTING SUBGRADE VOIDS BELOW A DAM SPILLWAY

David A. Hollema, Olson Engineering, Inc., Wheat Ridge, Colorado

Abstract

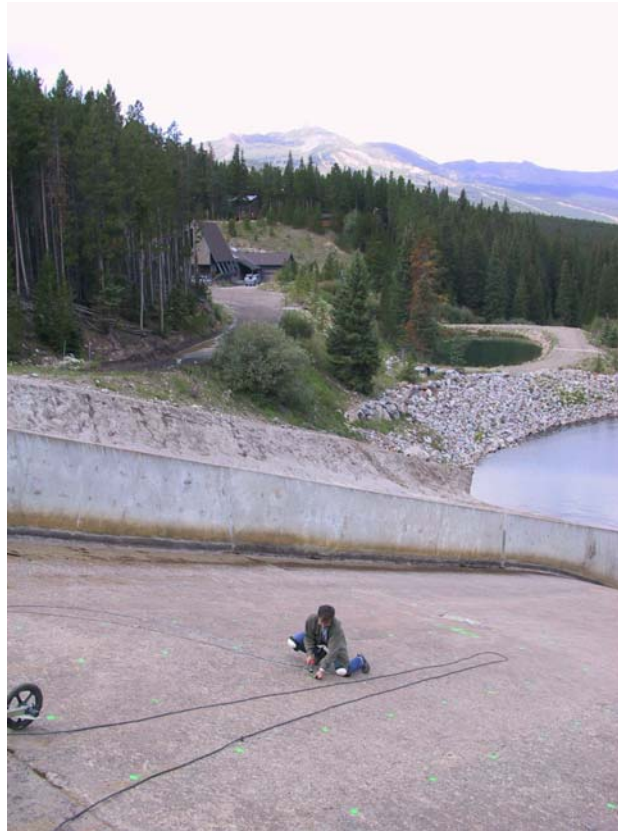
Figure 1.: Overview of the alpine dam spillway

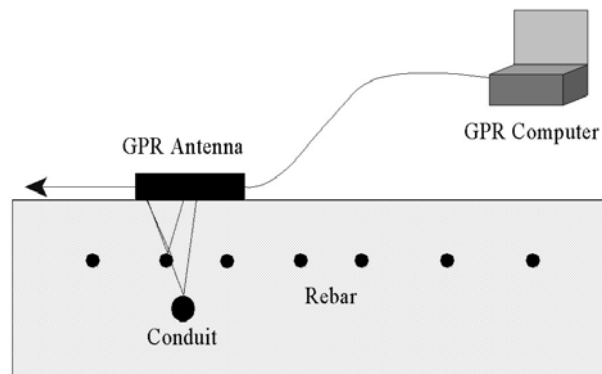
The GPR method involves moving an antenna across a test surface while periodically pulsing the antenna and recording the received echoes, as diagramed in Figure 2 for a typical concrete slab. Pulses are sent out from the GPR computer driving the antenna at a frequency range centered on the design center frequency of the antenna, in this case 400 MegaHertz (MHZ). These electromagnetic wave pulses propagate through the material directly under the antenna, with some energy reflecting back whenever the wave encounters a change in electrical impedance, such as at a rebar or other steel embedment or air-filled void. The antenna then receives these echoes, which are amplified and filtered in the GPR computer, and then digitized and stored. A distance wheel records scan distance across the test surface and embedded features can be located as a given distance from the scan start position. For repetitive scanning, a standard survey is designed and adhered to as field conditions allow to minimize mistakes and to maximize data quality. Daniels expounds on the theory and application of the GPR method (1996).

Figure 2.: GPR Schematic

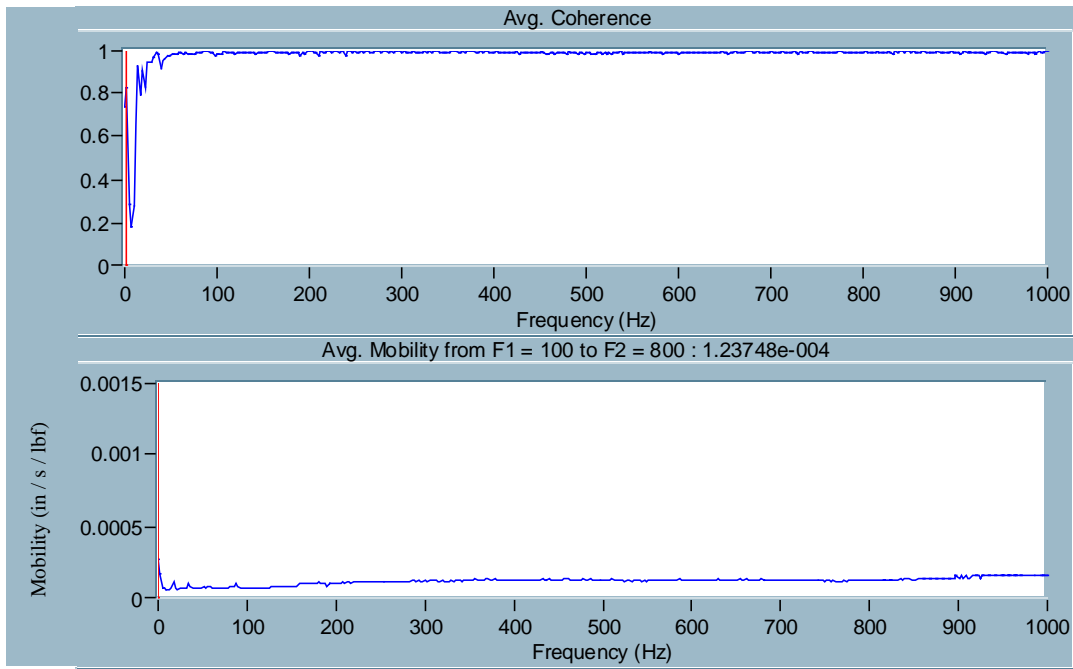
The Olson Instruments Freedom NDT PC performs the Fast Fourier Transform (FFT) Transfer Function operations on the time domain data to produce the mobility plots in frequency domain. Figure 3 is an idealized plot of mobility (vibration velocity amplitude per pound force) as a function of

Figure 3.: Example Slab IR plot of mobility indicative of good subgrade support from Test Location 5C

frequency measured in cycles per second or Hertz (Hz) for good subgrade support. The low, and comparatively smooth, mobility is an indicator of good subgrade support conditions. Irregular and higher amplitude mobility indicates a less stiff slab-subgrade support system, indicating poor (void)

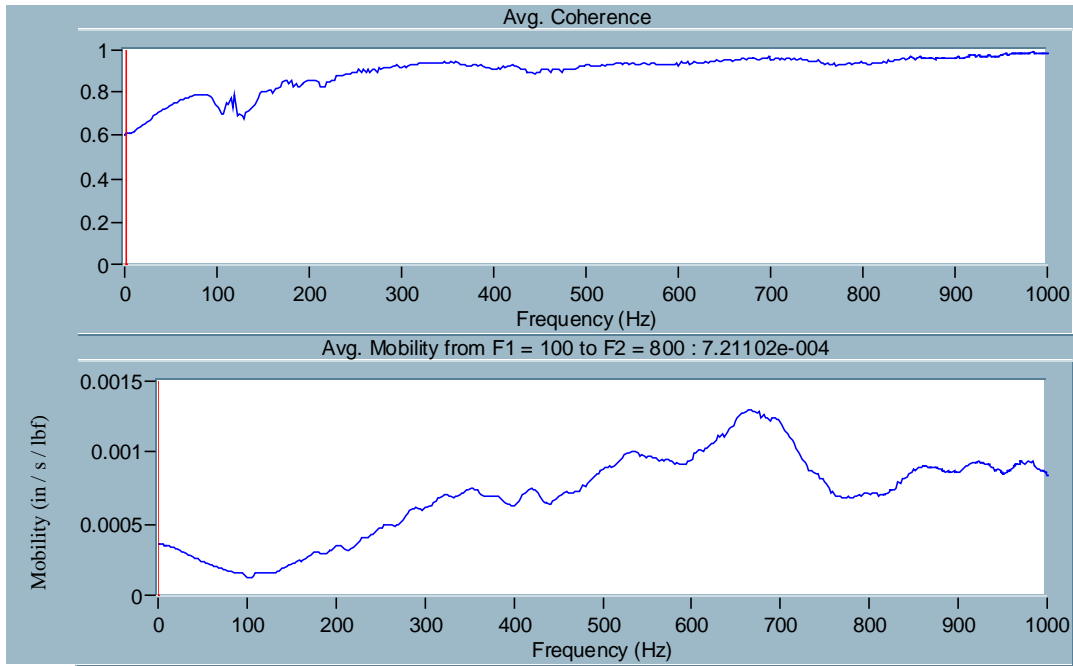
Figure 4.: Example Slab IR plot of mobility indicative of void/poor subgrade support from Test Location 24C

support conditions (Figure 4). The top plots are coherence and a value near 1.0 indicates good quality data.

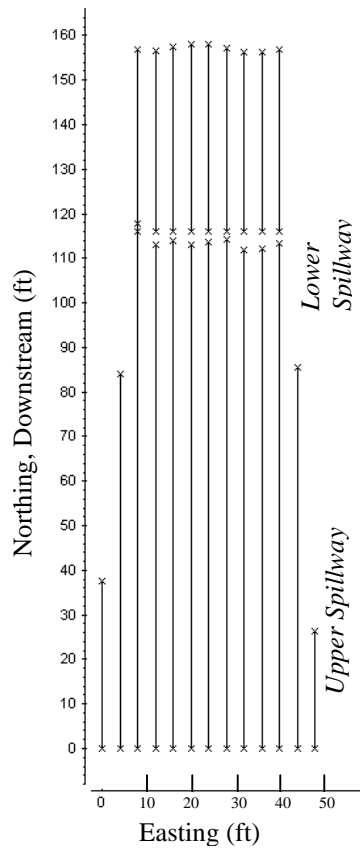
The GPR investigation was performed over a nominal length of 156 ft along the concrete spillway. All GPR data were collected using an antenna with a center frequency of 400 MHz and stored in a Geophysical Survey Systems Incorporated (GSSI) SIR-2000 GPR field data collection system. The GPR scanning was performed in 13 lines along the length of the spillway at lines spaced at 4 ft intervals as shown in Figure 5. The actual scanning was split into 2 portions— upper and lower spillway. Initially, scanning was performed at the upper portion of the spillway, from the crest downstream to a distance of 120 ft (Line 30). Next, the lower spillway was scanned, from 116 ft (Line 30) to near 156 ft (Line 41) below the spillway crest. All GPR scans were started 2 ft from the reservoir shore edge and continued downstream. The spillway tapered down uniformly from upstream to downstream causing the two outside lines on both sides of the spillway (L6, L5, R5, and R6) to 'pinch out' at a distance less than 156 ft. The two outside scans on both sides of the spillway are shorter than the nine inside scans.

Figure 5.: GPR scan locations for the upper and lower spillway

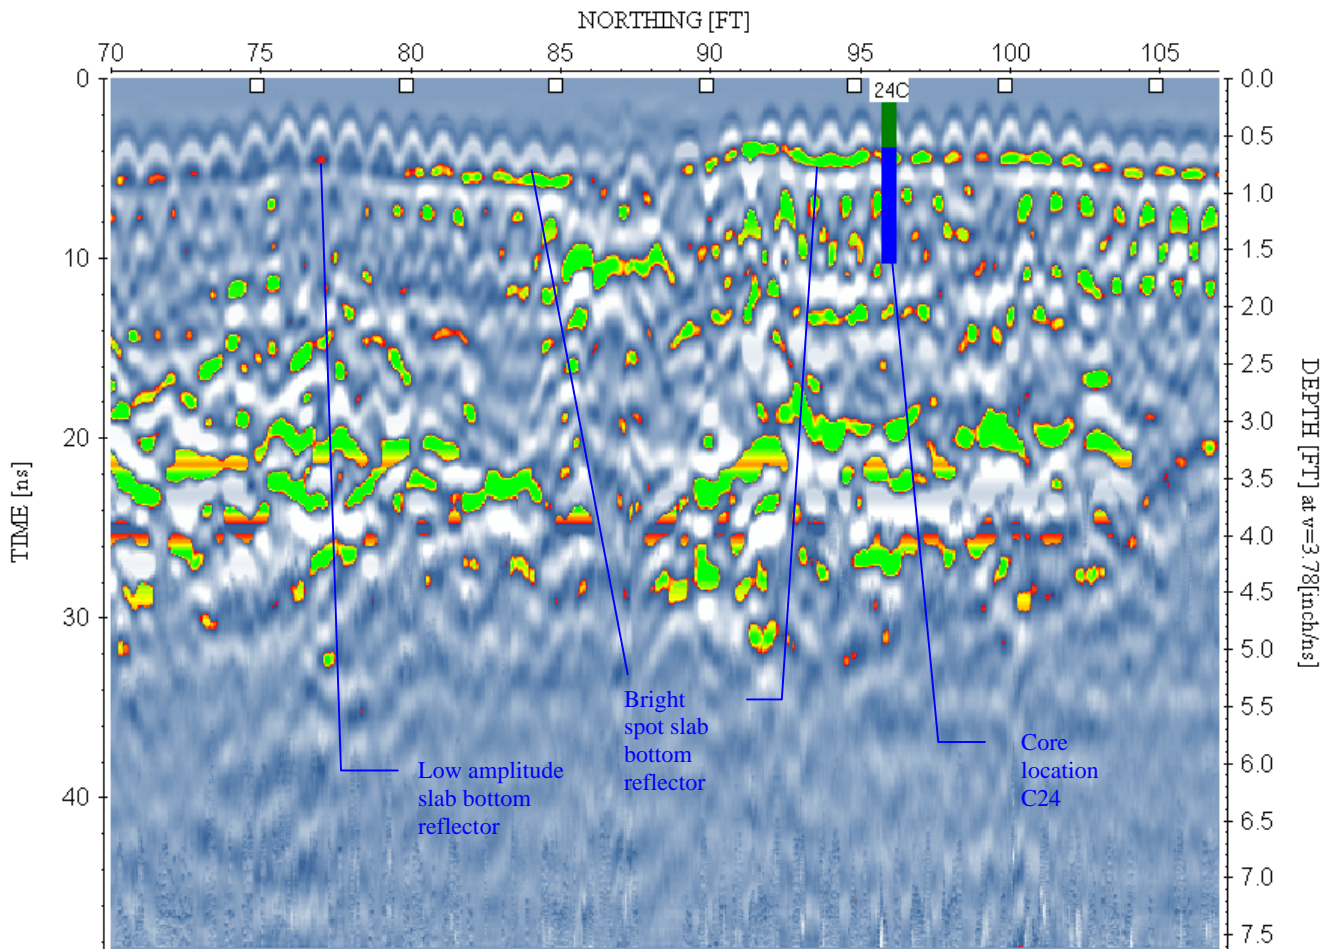
An example of GPR data recorded along the spillway center is presented in Figure 6. This is a waterfall plot of GPR data recorded along the centerline, 70 - 107 ft downstream of the spillway crest. The waterfall plot presented in the figure was manipulated and analyzed using a 2-D GPR analysis and display software package. Figure 6 shows 3 scan characteristics. The rebar mat ranges from a depth of 0.2 to 0.6 ft (depth in ft. on right hand vertical scale – left hand scale is time in nanoseconds). The slab

bottom reflection is evident at a depth ranging from approximately 0.6 to 0.8 ft. The amplitude of the slab bottom reflection was used for void detection analysis with “bright” and “low” amplitude reflectors shown in Figure 6. Stronger negative amplitudes are indicative of a strong dielectric constant contrast (concrete to air), evidence of potential voids. The core location along the centerline, used for concrete dielectric constant calibration, is shown in the figure as well (near 96 ft). The concrete at this location measured 7.25 inches thick.

Figure 6.: Example GPR data plot from the centerline, 70 – 107 ft below spillway crest

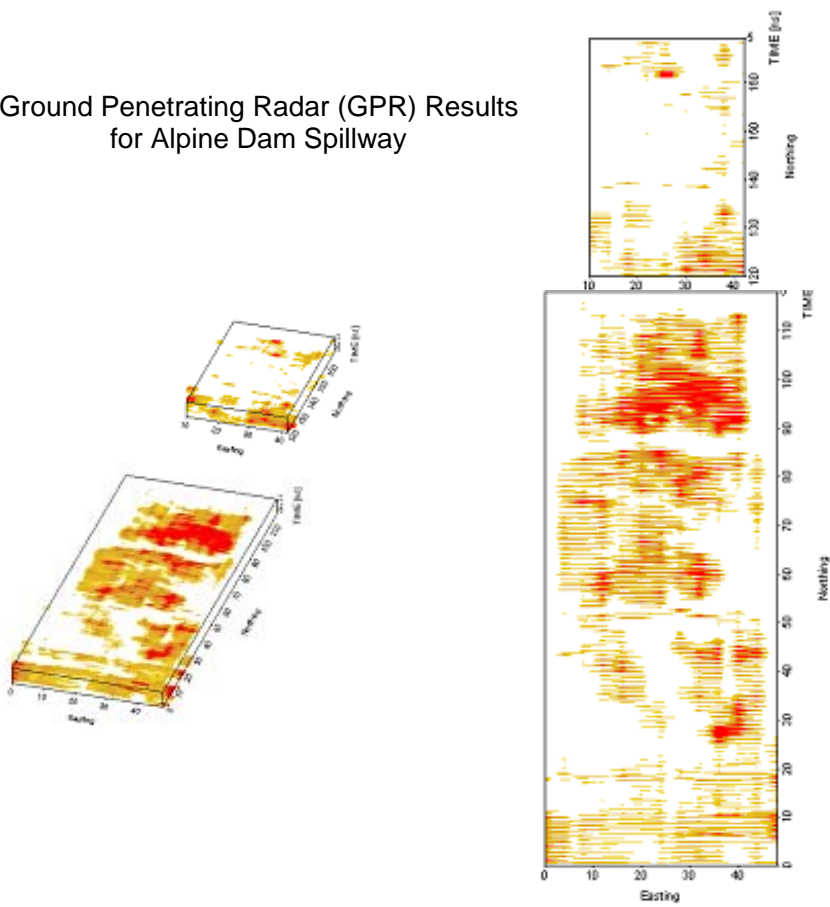
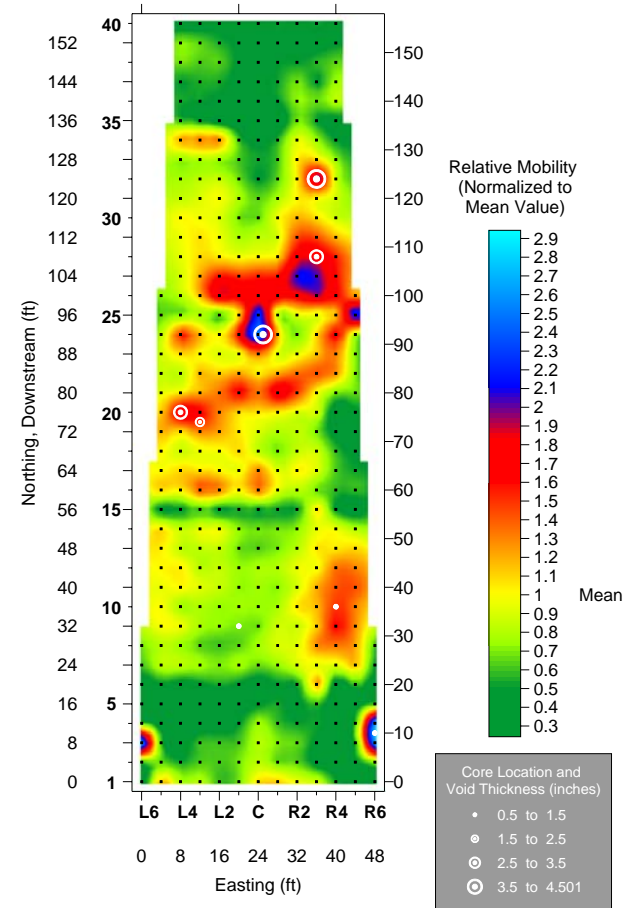
The results of the NDE investigation are presented graphically in Figure 7Figure . Figure 7 presents plan and perspective views of 3-D GPR data showing strong amplitude slab bottom reflection values, an image map contouring the Slab IR relative mobility values, and the core locations performed after the NDE investigation. The Slab IR and GPR results are discussed below.

The GPR data presented in Figure 7 (in both perspective and plan views) show the "bright", strong negative values for slab bottom reflection indicative of void and are the result of 3-D interpolation between the 13 lines scanned. The plots are separated into 2 sections, the upper and lower portions of the spillway. Areas of strong negative amplitude slab-bottom reflection or "bright spots" (red and orange shading in Figure 7) were interpreted as areas of potential voids. These bright spots are evidence of the strong contrast between the electrical properties of concrete and that of water or air-filled void versus the weaker contrast between the electrical properties of concrete and subgrade soil.

From the GPR data, much of the spillway shows evidence of potential voids. The two largest areas are between 55 - 80 and 90 - 110 ft below the spillway crest. Smaller areas of potential void appear in Figure as well. The GPR data did not allow for potential void thickness/depth approximation because of poor void bottom resolution; the core results provided this type of data. Core thicknesses were instrumental in our ability to identify the spillway thickness and hence identify areas of void.

Ground Penetrating Radar (GPR) Results for Alpine Dam Spillway

Slab Impulse Response (Slab IR) Relative Mobility Results for Alpine Dam Spillway

Figure 7.: GPR and Slab IR results for alpine dam spillway

The GPR and Slab IR data correlate well as is evident from the plots presented in Figure 7. White areas in the GPR plots (weak amplitude slab bottom reflection) correspond to green areas (low mobility) in the Slab IR image map and suggest locations for better subgrade support. The coring results, Table I, support the NDE data set results. Figure 7 plots the core locations and the size of each symbol relates to the thickness of the corresponding void. Voids were encountered for all locations cored, however, the thinner voids were found in areas of relatively low mobility (Slab IR) and weak slab bottom reflector (GPR) such as core 3/4R6. These areas suggest better subgrade support. One exception was core 3/4R6 where a thin, 0.5 inch thick void was discovered. A proper explanation of this core may be the fact that significant voids are often closely surrounded by areas of good subgrade support, within a 3 to 5 foot radius. Even with NDE results, coring can be a hit or miss operation. The correlated results infer that the Slab IR image map does indeed show locations of potential voids as opposed to changes in slab thickness.

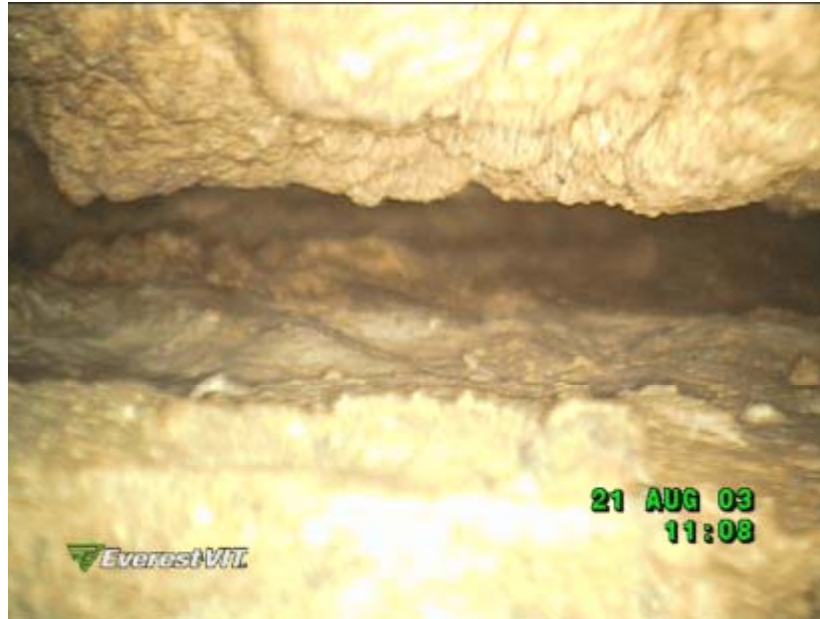
Video borescope probing was performed in the coreholes to provide visual confirmation of the NDE results. Both individual JPEG images as well as VHS recordings were obtained in each corehole. Four images were captured in each of eight boreholes at four different orientations: upstream, west, downstream, and east. The remaining corehole, 3/4R6, was not investigated with the borehole because it had only a ½ inch void and was filled with water to the bottom of the concrete. Figure 8 shows a borescope still-shot from corehole 9L1 (Easting line L1, Northing line 9 - see Figure 7 for location). The spillway concrete, void, and underlying subgrade are all evident in the still-shot. The images recorded with the video borescope showed voids extending some distance from the corehole and proved the NDE results for all coreholes tested.

Figure 8.: Borescope still-shot in corehole 9L1
